Quality Assurance and Source Inspection

Contract #: 04-0120F4Cty: SF/ALA Rte: 80 PM: 13.2/13.9File #: 69.28**WELDING INSPECTION REPORT****Resident Engineer:**Siegenthaler, Peter**Address:** 333 Burma Road**City:** Oakland, CA 94607**Report No:** WIR-024684**Date Inspected:** 22-Jun-2011**Project Name:** SAS Superstructure**OSM Arrival Time:** 700**Prime Contractor:** American Bridge/Fluor Enterprises, a JV**OSM Departure Time:** 1900**Contractor:** Zhenhua Port Machinery Company, Ltd (ZPMC), Changxing Island **Location:** Shanghai, China

Segment 14 West

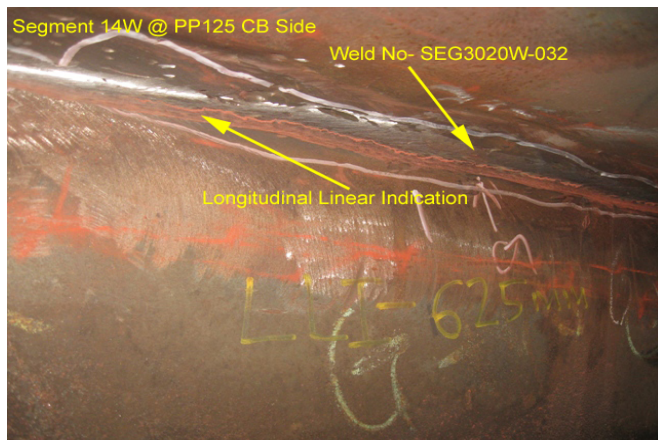
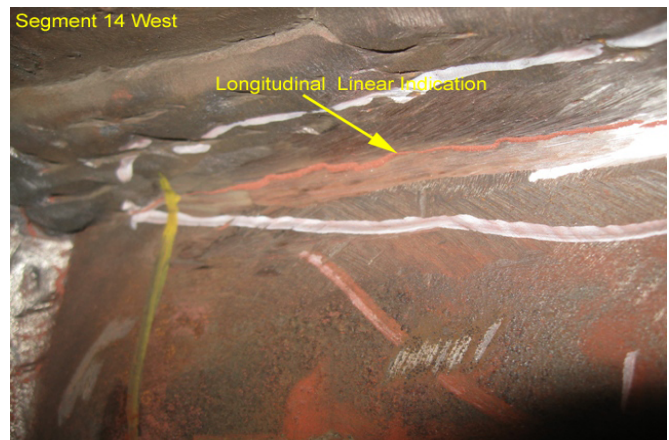
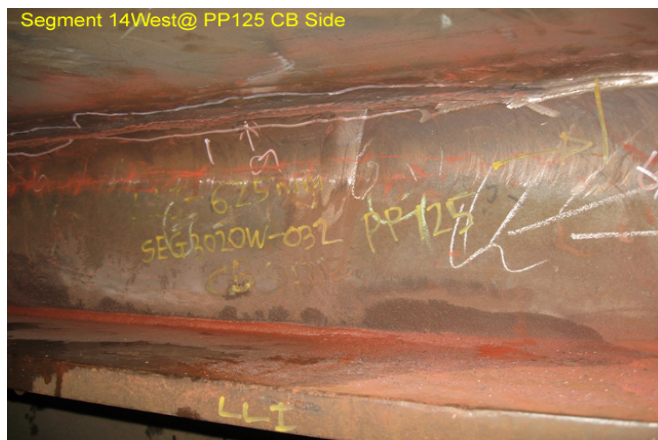
During random witness of weld joints is identified as SEG3020W-032 this QA observed Longitudinal Linear crack on the welds. This QA along with ABF QA MT Technicians marked the affected areas and informed ZPMC Quality Control (QC) CWI indentified as Mr. An Qing Xiang of this issue. Mr. An Qing Xiang informed this QA that the cracks would be corrected in a manner compliant with the contract documents. This QA Inspector also informed to Lead QA Inspector of the issue. See attached photos for further details.
